Federalsburg, MD Bakery

Asset preservation coating and remediation project executed by Alpine Painting & Restoration Services of Chalfont Pennsylvania

Part 1: Illustrates preparation, remediation, and restoration of bakery exterior, metal siding, and CMU Masonry walls

Part 2: Illustrates flour silos remediation and restoration

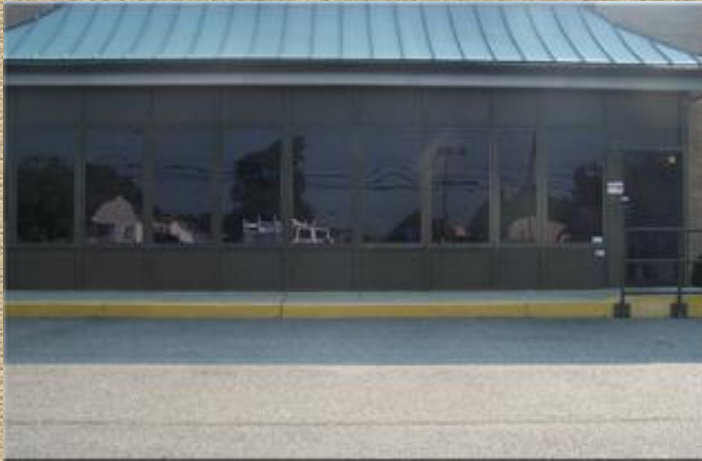
Before

The following Images illustrate the urethane finish in place on restored storefront metal:

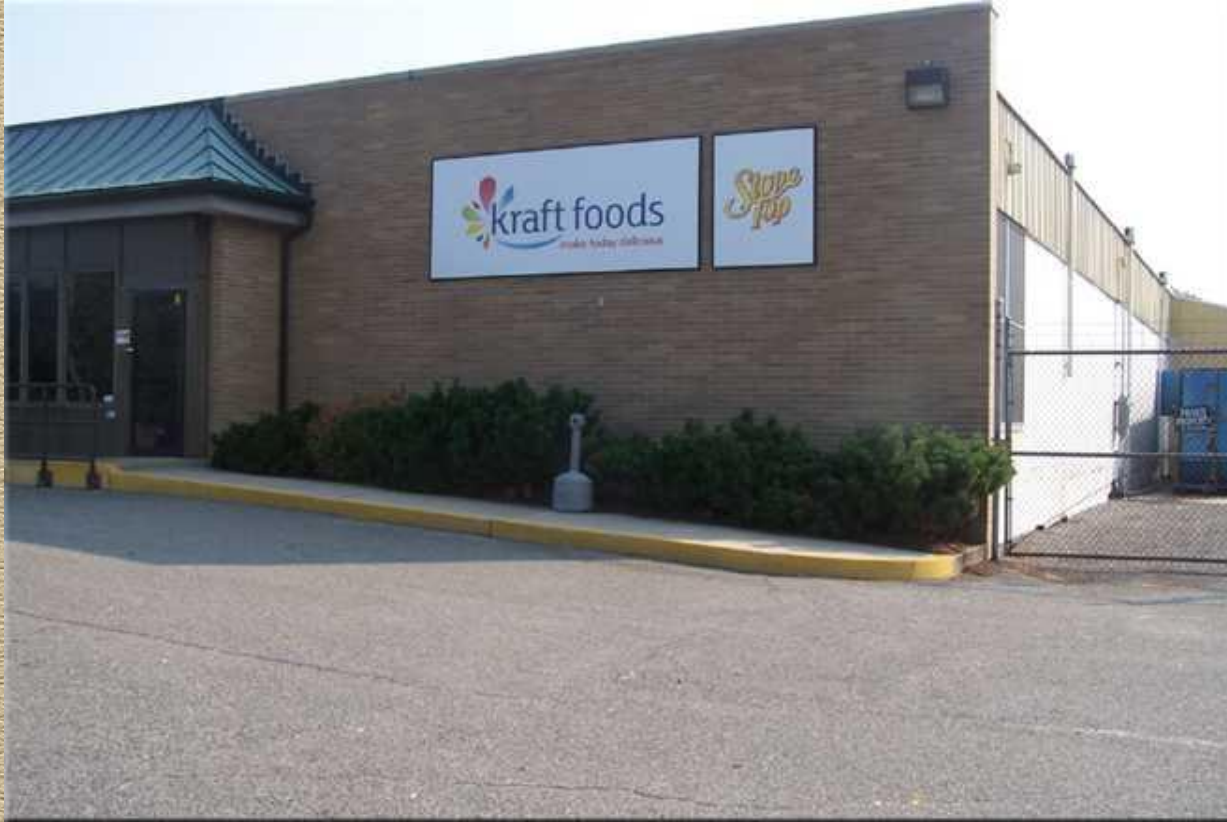
Image illustrating cleaned, restored, and waterproofed masonry as well as removal of General Mills signage and installation of new Kraft Foods signage

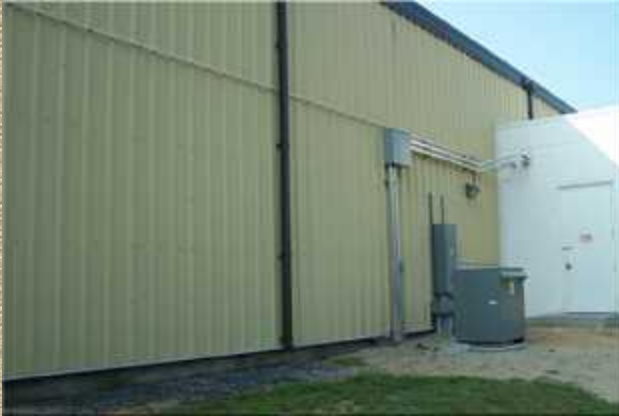
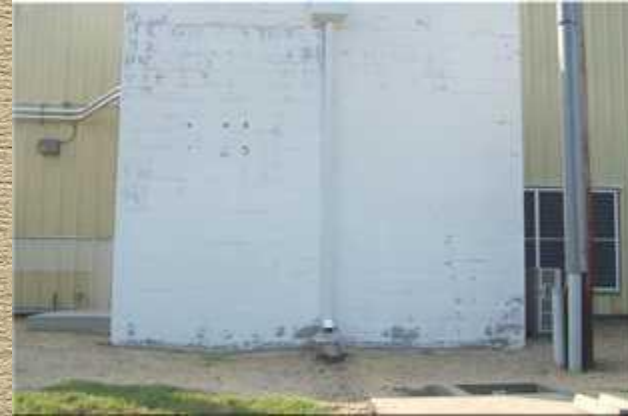
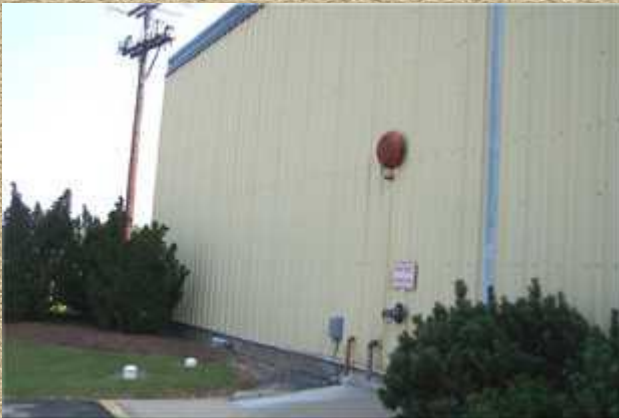
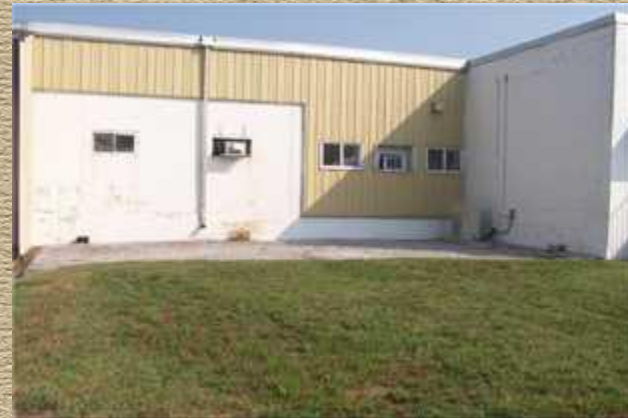
Miscellaneous images of various substrates prepared for coating installation

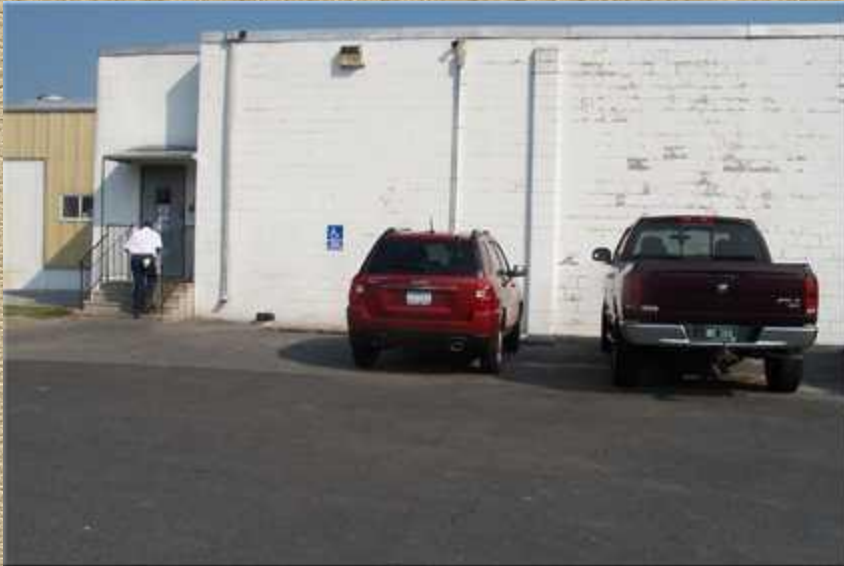
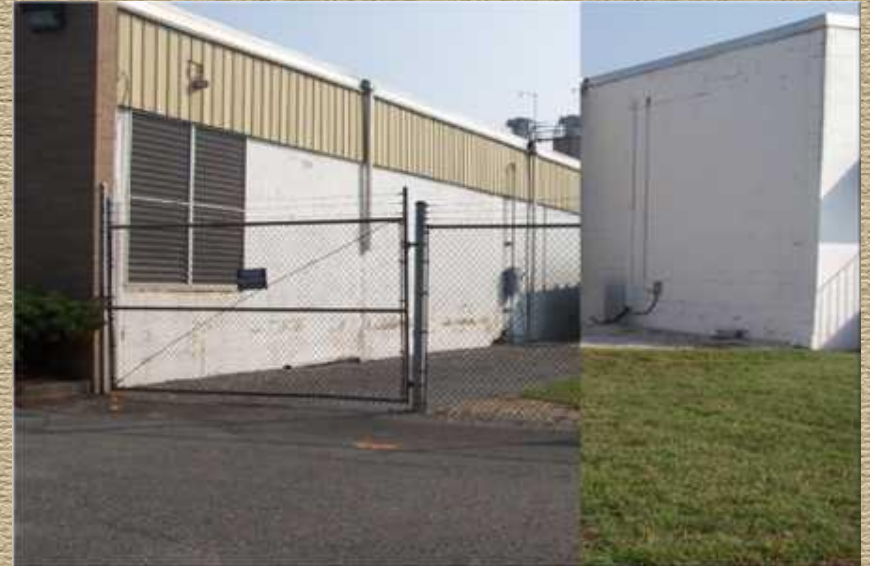
The following images illustrate the degree of water intrusion

Water intrusion in CMU (cinder block) walls at various locations along different elevations prior to installation of pigmented water proof coating

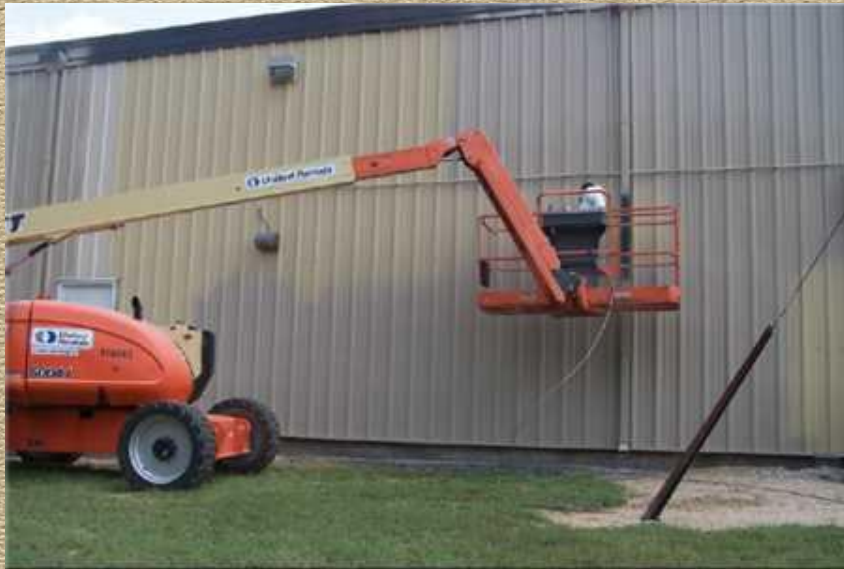
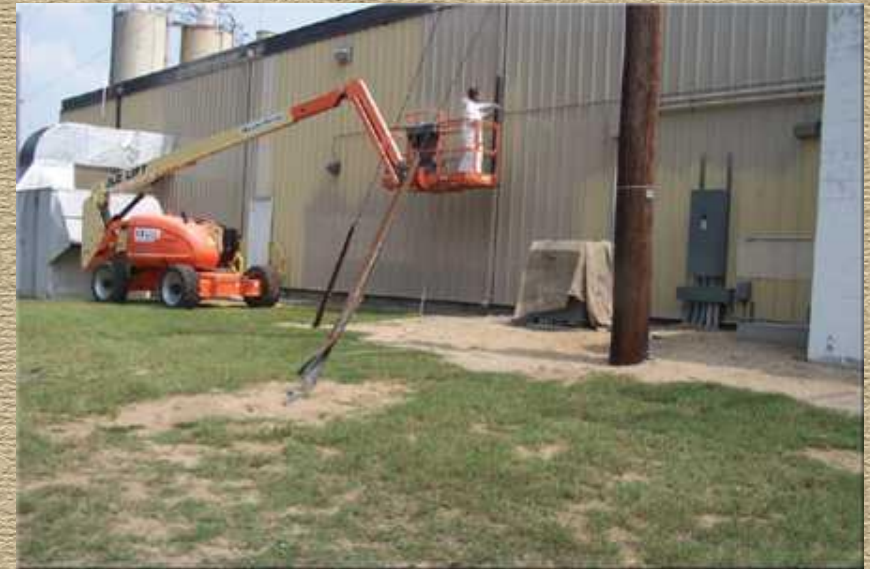
Progress images of fluorourethane coating being installed on prepared corrugated siding

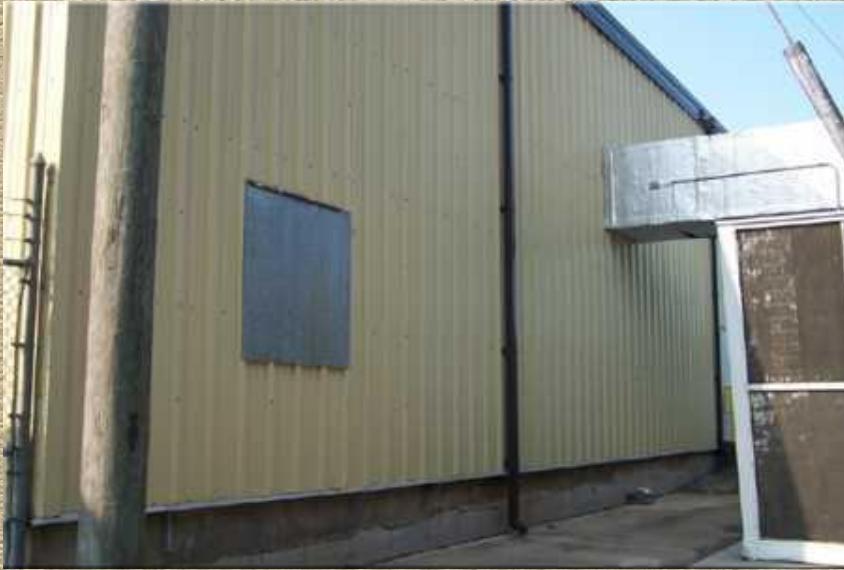
Before

Images of prepared and finished siding

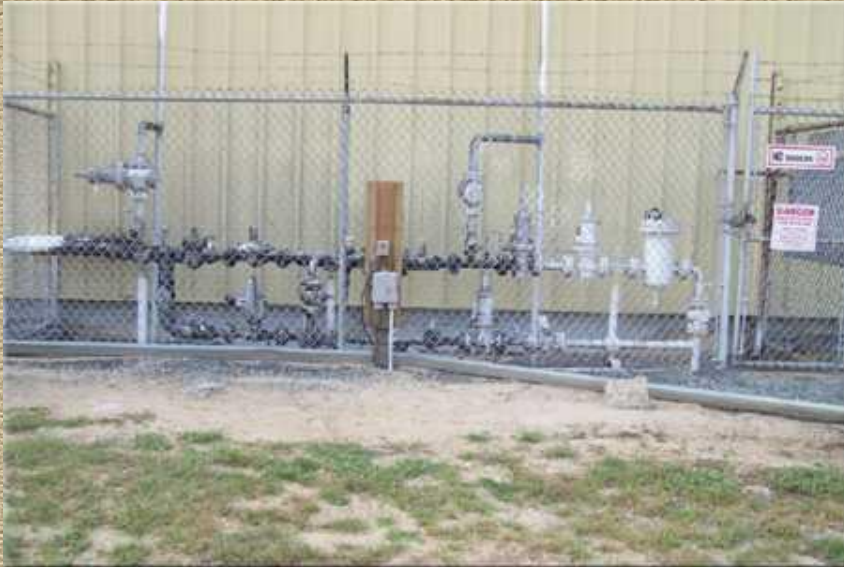
Before

Images of the high pressure natural gas valve and regulator farm painted with safety yellow urethane to comply with present day ANSI color coding for safety and visibility

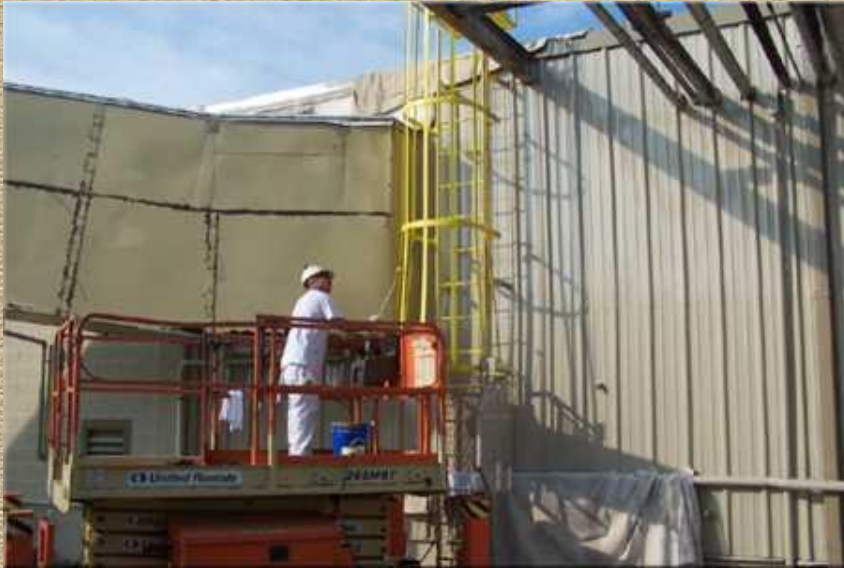
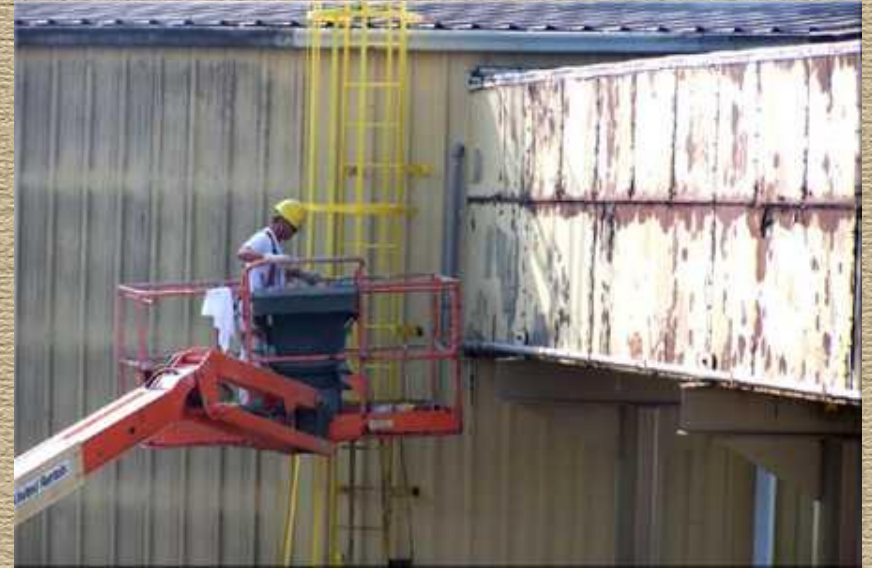
Following images illustrate the installation of OSHA safety yellow urethane to roof access ladders and fall arrest cages in compliance with present day ANSI and OSHA regulations

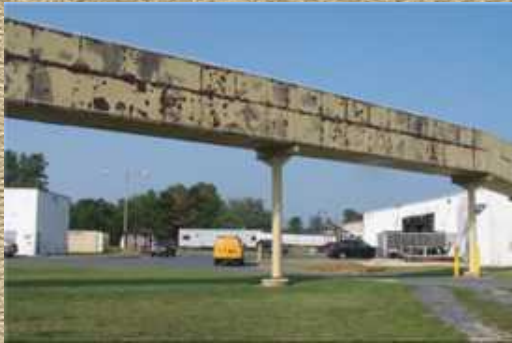
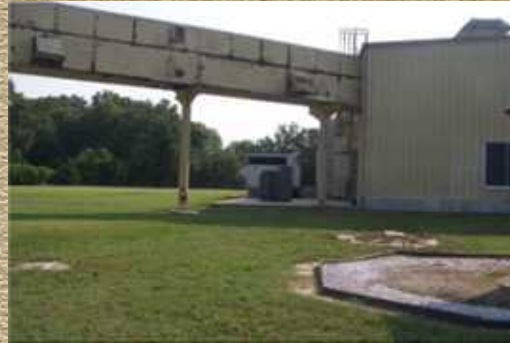
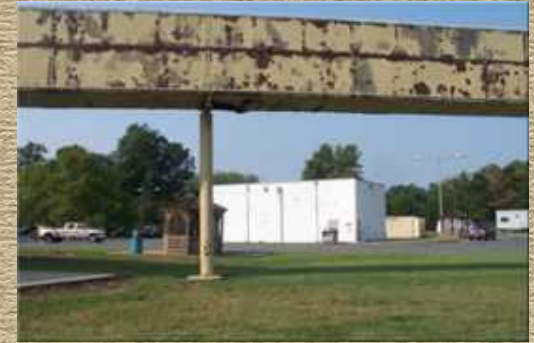
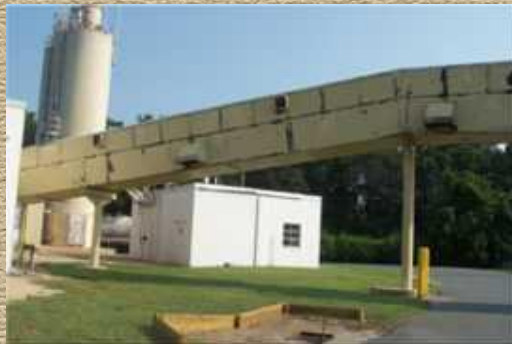
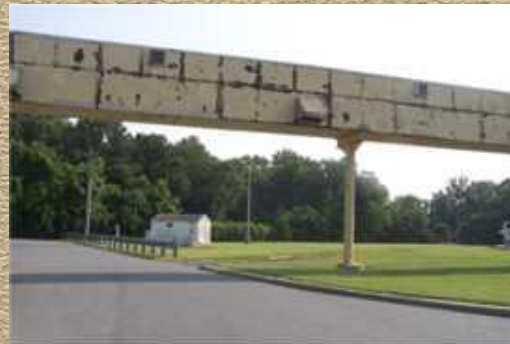
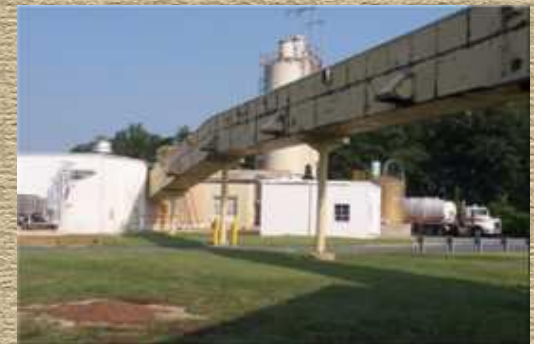
Various images illustrating water blasted and prepared conveyor bridge tunnel

After water blasting process was completed a thorough inspection was performed on the exterior skin revealing various stages of severe deterioration.

As of this writing entire skin of bridge tunnel is being repaired and resided with new corrugated siding and will be coated upon completion.

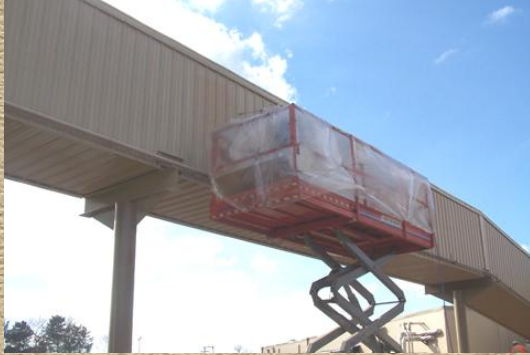
Various images of fluorourethane coating system being applied to newly installed metal skin of conveyor bridge to maintain color continuity between bakery & conveyor bridge

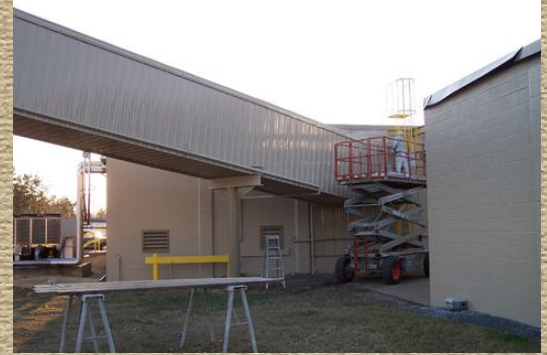
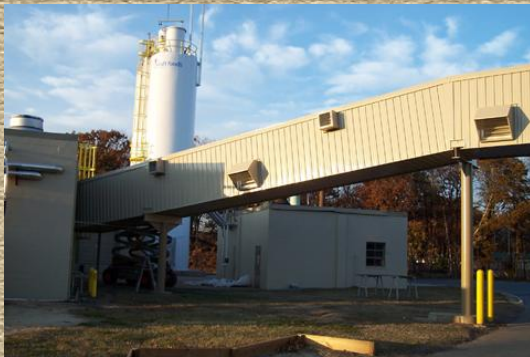
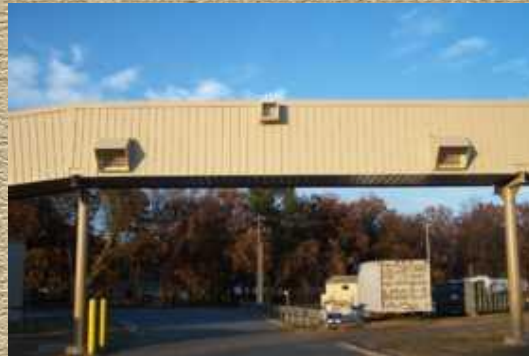
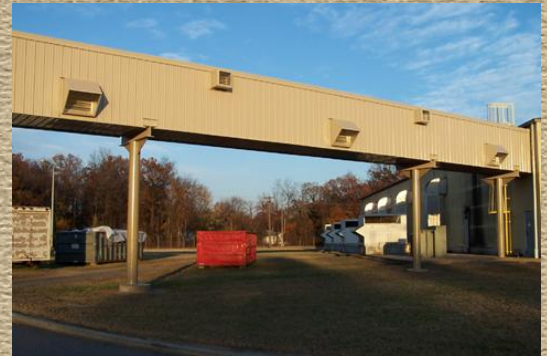
Below images depict finished coating system on bridge skin

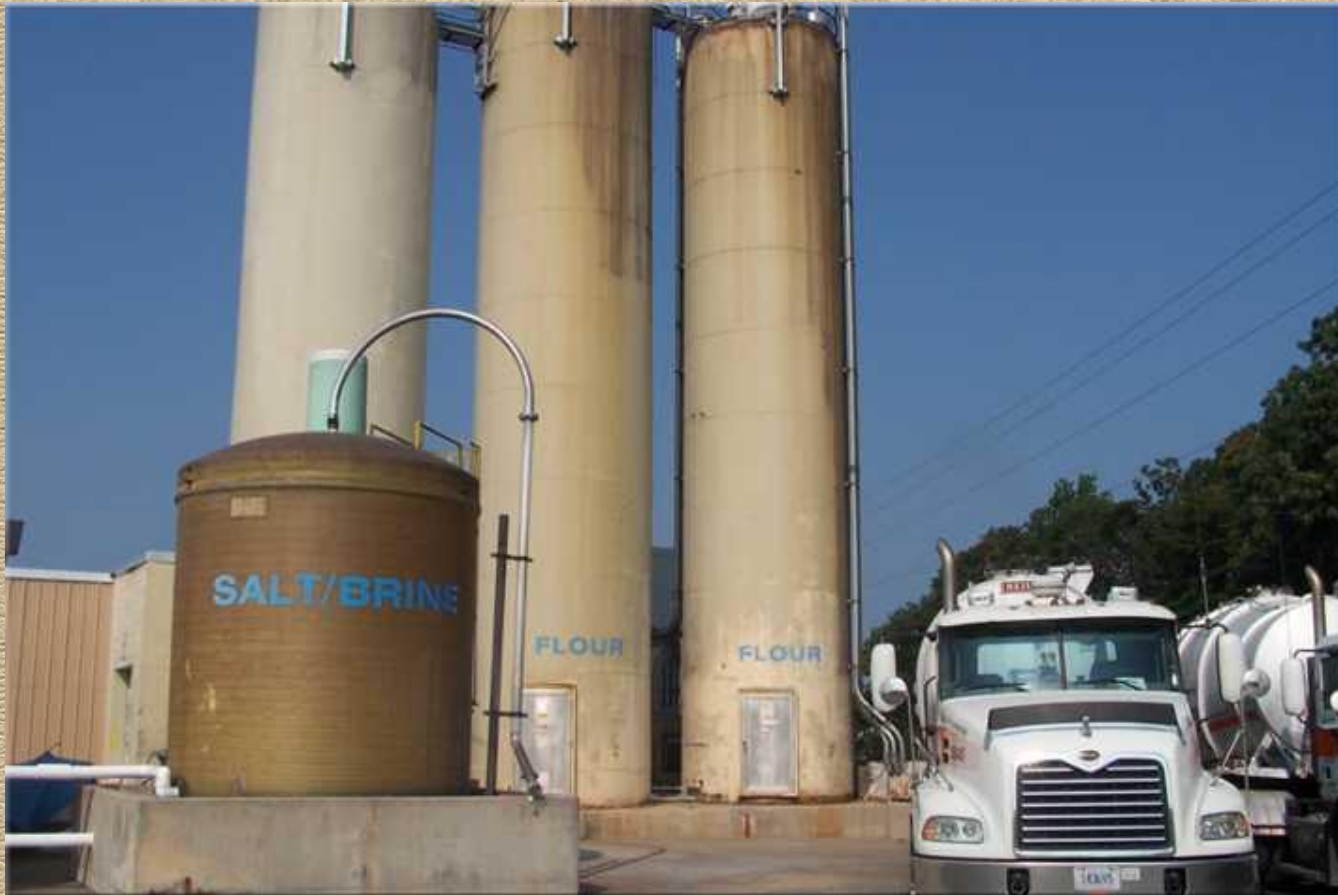
Mild Steel Silos Exhibited a Marked and distinguishable degree of corrosion where if allowed to continue the asset integrity would be compromised.

Facility Flour Silos Prior to Remediation and Restoration

Alpine Painting engineered a corrosion control system comprised of:

- High pressure water blast prep as well as machine tool preparation with a 6 to 10 mil anticorrosive polyamide epoxy base coat installation
- 4 to 7 mil fluorourethane finish coat system.
- Kraft Foods White color installed

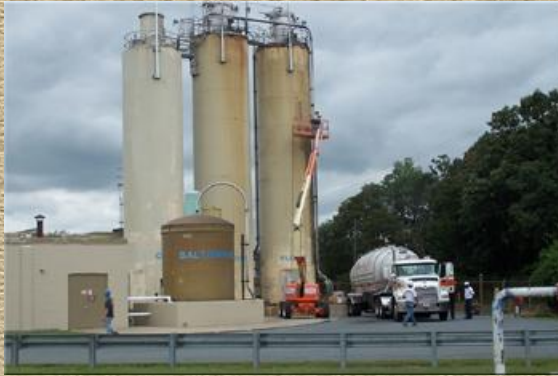
High pressure water blasting in process

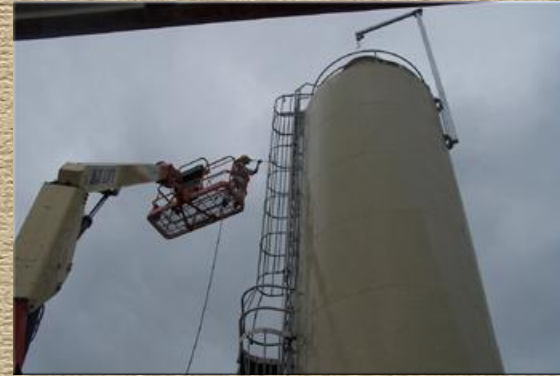
Distance shot of silo 3 being water blasted with operator using an 85 foot articulating boom

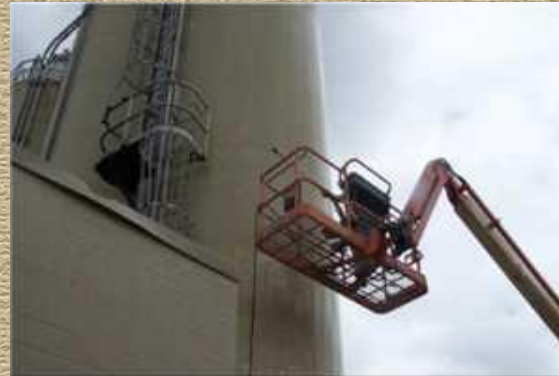
Image illustrates operator working in compliance with all present day OSHA safety standards

Additional image of water blasting prior to coating install

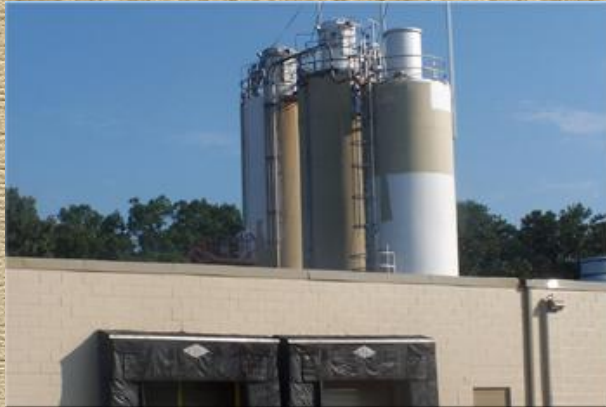
Silo Coating in Process

Progression image of silos being coated with polyamide epoxy base coat

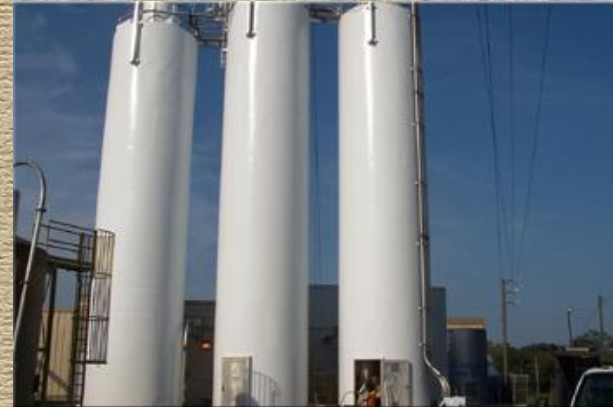
Image of silos completed with polyamide epoxy base coat

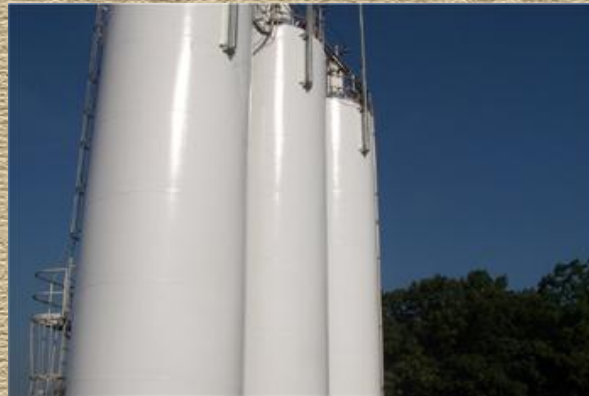
Image of silos with fluorourethane finished coating installed

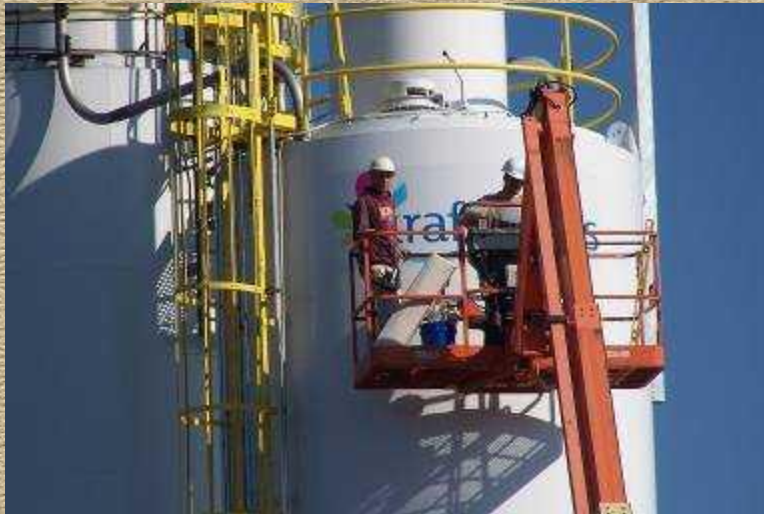
Sign installation in progress

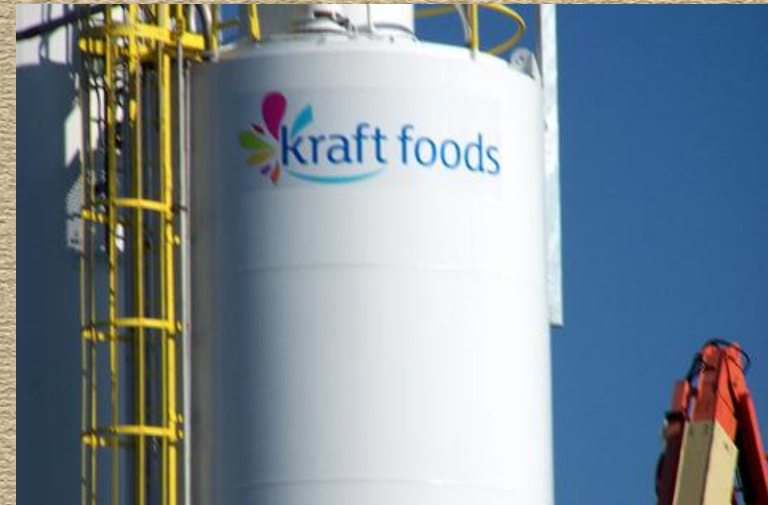
Completed sign installation on silo one
